# UNDERWATER BRIDGE INSPECTION REPORT

STRUCTURE NO. 84508  
CSAH NO. 30  
OVER THE  
RED RIVER OF THE NORTH  
DISTRICT 4 - WILKIN COUNTY

PREPARED FOR THE  
MINNESOTA DEPARTMENT OF TRANSPORTATION  
BY  
COLLINS ENGINEERS, INC.  
JOB NO. 5221 (CEI 55)

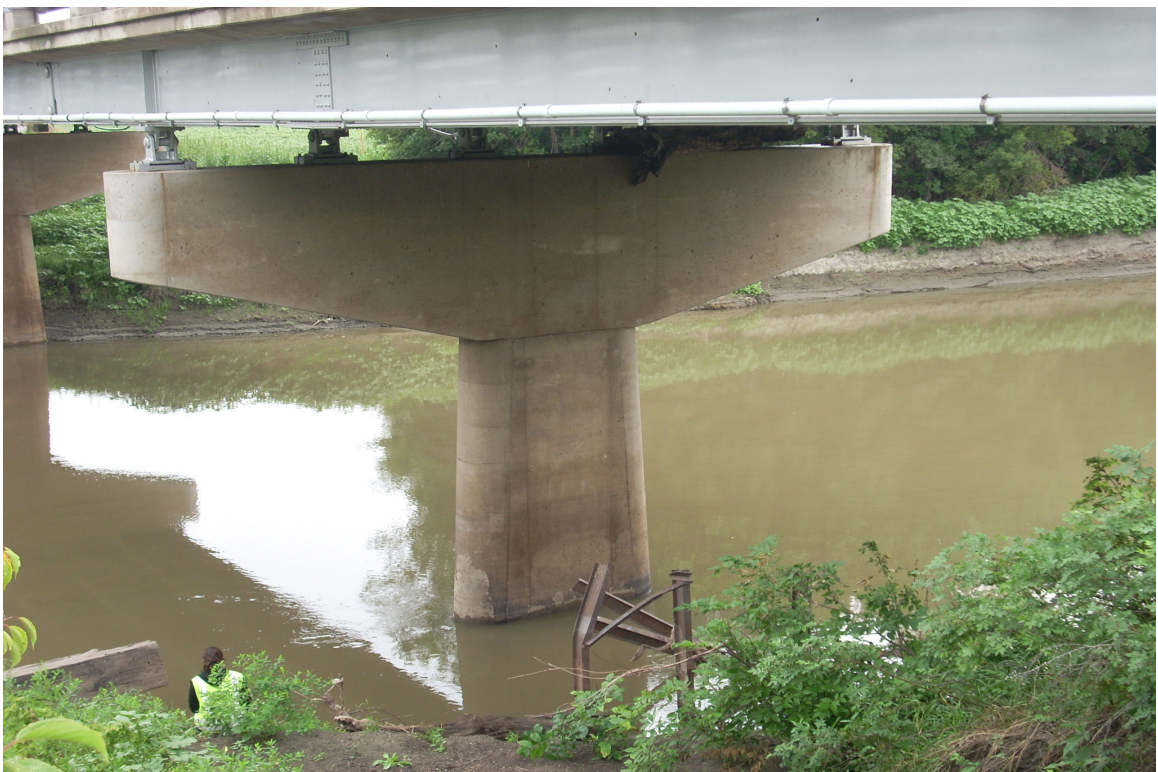
- (A) There was a 2 foot diameter log located along the upstream nose of Pier 1 extending from the West face to the West shoreline.
- (B) Erosion was observed at the embankment along the West Abutment which was beginning to undermine the pile cap.
- (C) Steel I-beams with scattered debris hung up within them were observed extending from the channel bottom to 7 feet above the waterline, along the West face of Pier 1 to the shoreline. There was also a 2-foot-diameter log across the upstream nose of Pier 1.

Photograph 2. View of Pier 1, Looking Southeast. Note I-beams Protruding from the Waterline.

- (A) Monitor the timber debris, and if found to be increasing in the future, removal operations may become warranted.
- (B) Evaluate the bank erosion and assess the need to provide riprap along the West Abutment to prevent further erosion.

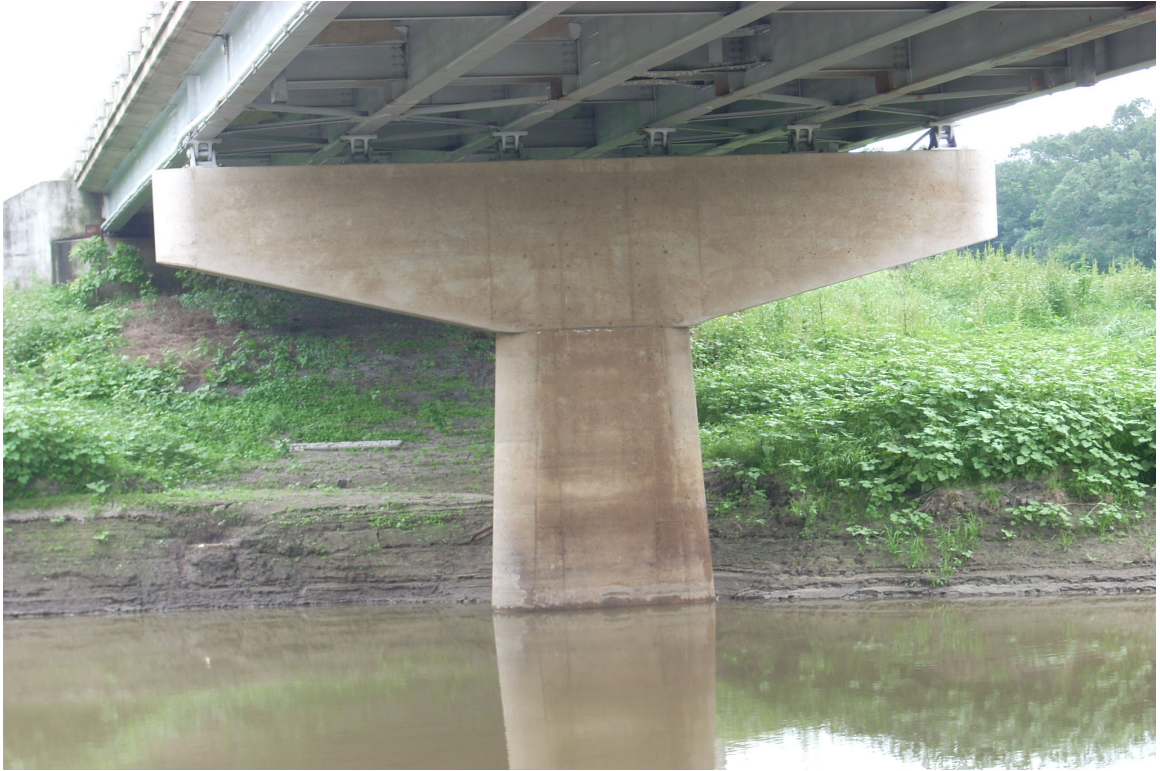
The substructure unit inspected at Bridge No. 84508, Piers 1 and 2 were found to be in good condition with no significant structural defects observed. Pier 2 was out of the water during the previous inspection, but it was in the water at the time of current inspection. The channel bottom appeared stable with no significant scour and with no appreciable changes since the previous inspection.

Photograph 3. View of Pier 2, Looking East.

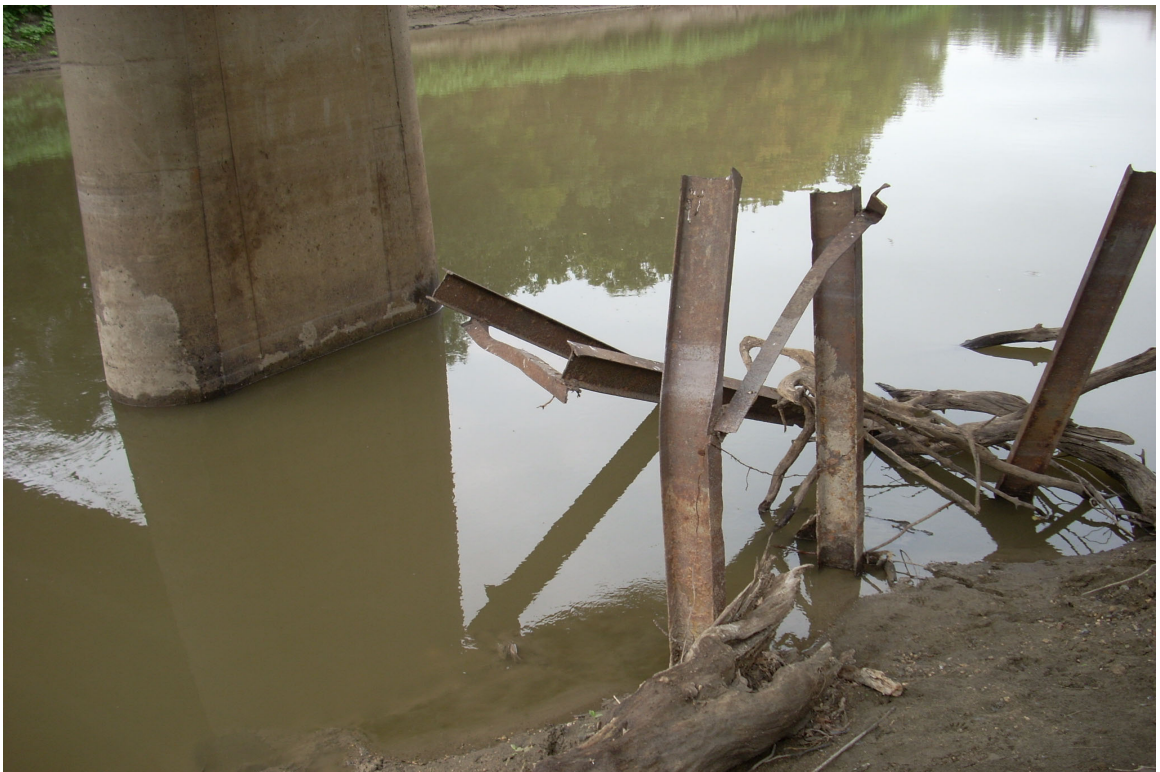
Photograph 4. View of I-Beam debris between Pier 1 and the shoreline looking Southeast.

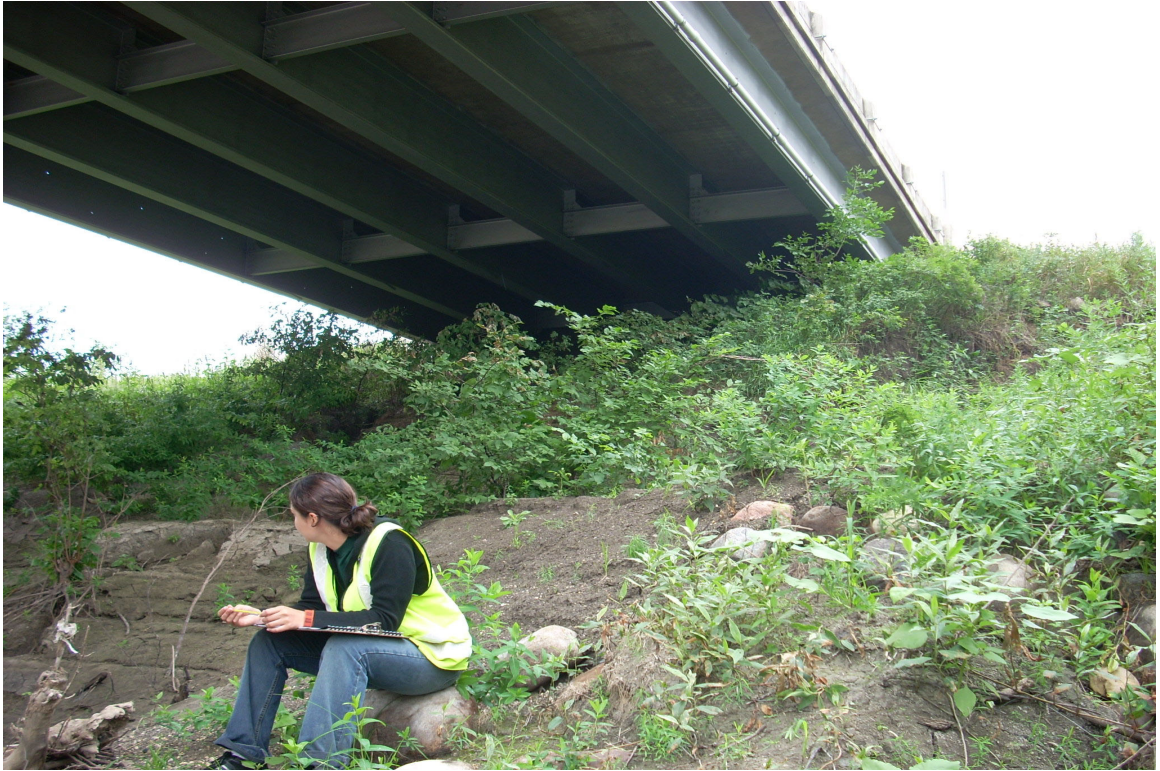
Photograph 5. View of West Abutment, Looking Southwest.
